GIANT MINE REMEDIATION PROJECT

Status of the Environment from June 2021 to June 2024

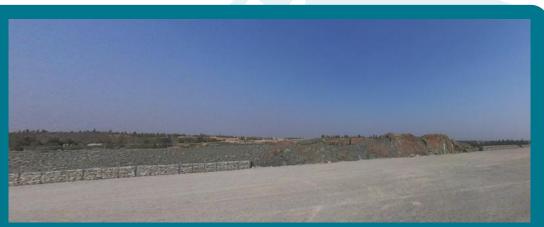
Retaining walls for the freeze pad are made of rock covered in wire mesh (called gabion baskets) rather than concrete blocks.

This gives the pad a more "natural" appearance in the surrounding environment.

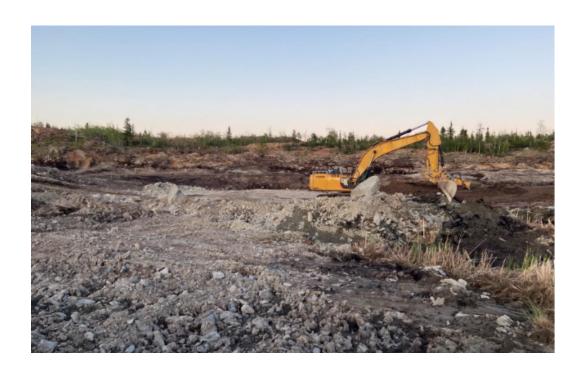
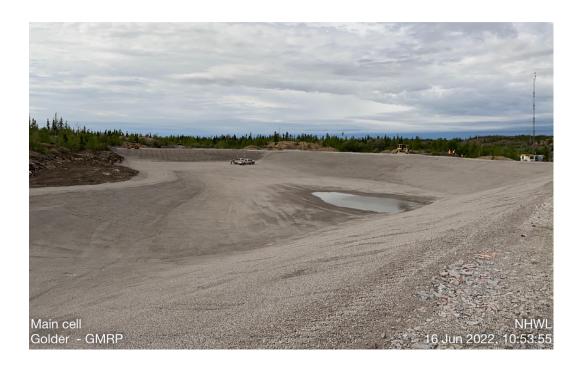
Photo 1: Non-hazardous Waste Landfill Construction Upper photo: clearing and site preparation Lower photo: completed main cell of the non-hazardous waste landfill

A liner was installed when building the non-hazardous waste landfill. It is called a bituminous geomembrane (BGM) liner.

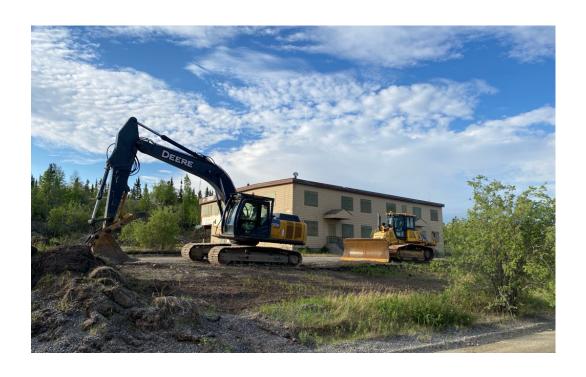
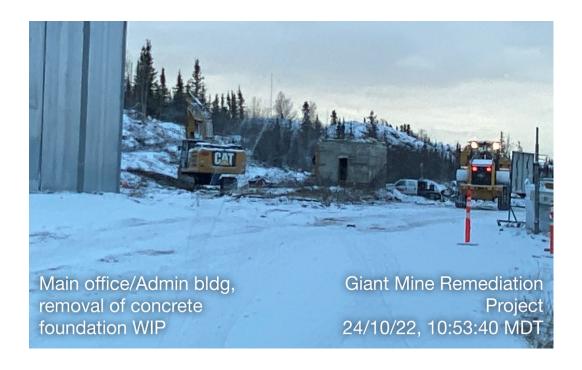
Photo 2: Building Demolition
Upper photo: site preparation near main office building
Lower photo: deconstruction of main office building and clearing of debris

tion of the site, including the main office and planner building. Non-hazardous and hazardous materials were sorted and put in the landfill or removed from site (following the Waste Management and Monitoring Plan¹⁰).

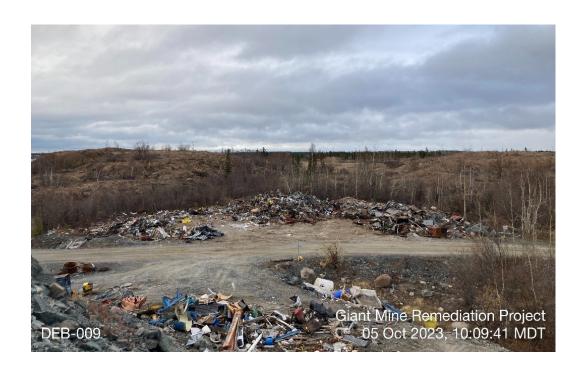
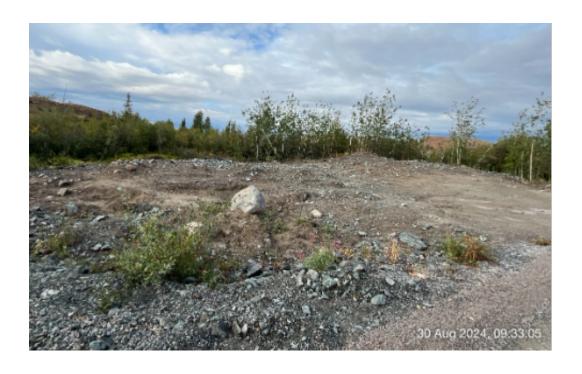
Photo 3: Debris Pile Removal Left photo: example of larger debris pile on site Right photo: area after the debris pile was removed

- **Debris pile removal** (Photo 3): sorted non-hazardous and hazardous debris from piles scattered across the site and put in the landfill or removed material from site (following the <u>Waste Management and Monitoring Plan</u>¹⁰).
- Start of new water treatment plant construction (Photo 4): cleared area, removed contaminated soils, blasted corridor for pipeline to carry treated effluent down to Yellowknife Bay, drilled the new intake wells (pump installation to be completed in 2025), started the building foundation, and monitored that construction water was not released to the environment.
- Underground stabilization: placed paste backfill in underground voids located near the surface to help stabilize the underground.

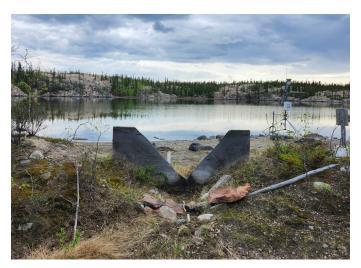
Photo 6: Dry Stream Bed at Pocket Lake in Spring 2024

Less water was also seen at Baker Pond on site, as well as nearby Trapper Lake and Pocket Lake (Photo 6). The GMRP monitors water level and flows in these waterbodies; the information from the monitoring is shown in Figure 9, Figure 10, and Figure 11. When the drought conditions end and wet conditions are experienced, it may take a while for the waterbodies to fill up and for the streams to flow again.

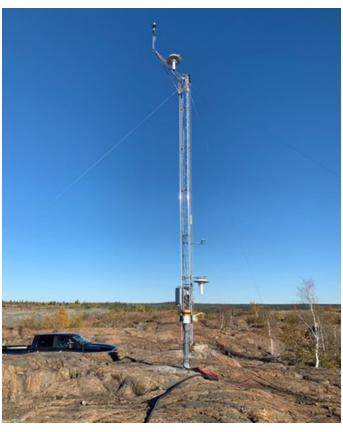
Photo 7: Meteorological Station on Site

Routine monitoring for signs of dust in the air (visible dust) is also done by all site workers. To help support dust monitoring, weather data such as wind speed and direction are collected at the on-site meteorological station (Photo 7) and data from the Yellowknife airport. Table 8 summarizes the dust monitoring. More details on the monitoring can be found in the <u>Dust Management and Monitoring Plan³²</u>.

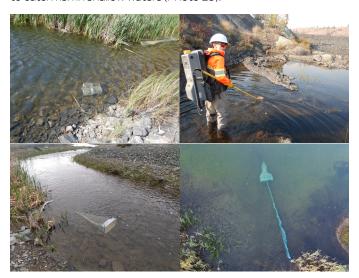
In 2024, fish surveys were completed in Baker Creek during the spring and summer to record the type and number of fish present. Fish surveys were done using visual surveys along the shoreline, drone surveys from the air, snorkelling surveys in the water, and a variety of fishing methods, including minnow traps, backpack electrofishing, drift nets, and fish traps called "fyke nets" that are used to catch fish in shallow waters (Photo 23).

Photo 23: Examples of Minnow Traps, Backpack Electrofishing (upper photo from left to right) **Drift Nets, and Fyke Nets** (lower photo from left to right)

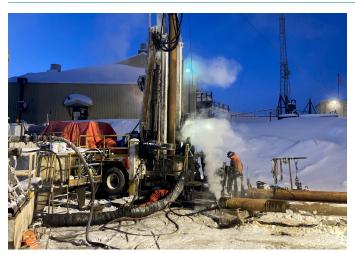
Photo 29: Drilling and Well into the Underground Left photo: drill rig on site for the new water intake for the water treatment plant Right photo: completed well

Minewater wells: Two new wells were installed from the surface down to the minewater in the underground, in the core industrial area of site. Water will be pumped up from the underground through these wells and it will be piped directly to the water treatment plant for treatment (Photo 29). Eventually, the wells at the north end of the mine that pump to the Northwest Pond and to the existing effluent treatment plant will be decommissioned.

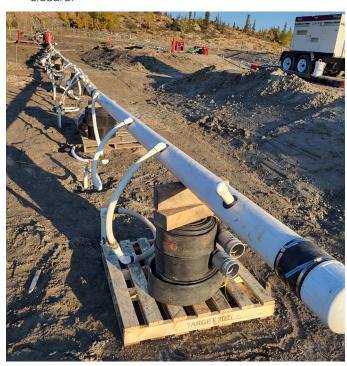
- The Tailings Containment Areas will need to be emptied of surface water (dewatered) so they can be remediated, and construction equipment can work in the area to cover the ponds. In fall 2022, a dewatering test on the saturated tailings was conducted in the South Pond (Photo 30). The test involved using digging holes in the tailings, installing wells in the holes, and then applying suction from a vacuum to remove water (called "an enhanced vacuum wellpoint system"). This method worked and can be used on site as part of remediation to improve tailings strength to allow South Pond tailings to be relocated and shaped for closure.

Photo 30: Equipment on South Pond Used to Remove Water from within the Tailings to Make the Area Stable for Equipment to Work

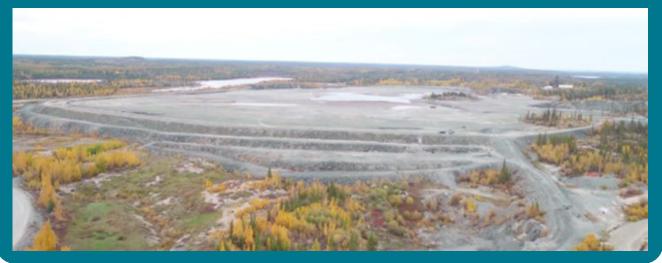
Northwest Pond (looking north), which includes dams with Very High consequence classification

Of the 26 dams at site, only four dams have the consequence classification of Very High (Dams 21A, 21B, and 21C and B2 Dam).

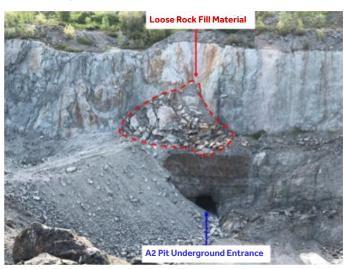
Photo 34: Clearing of Unstable Material in A2 Pit Upper photo: clearing of catchment bench above A2 Pit underground entrance Lower photo: after removal

- 1. The area underneath seven pits (A1, A2, B1, B2, B3, B4, and C1 pits) was stabilized as part of underground stabilization work.
- Loose rocks were removed from the A2 Pit wall (called a
 pit catchment bench). Clearing of loose materials on pit
 benches helps reduce the risk that the material will tumble down onto workers (Photo 34). The loose rocks were
 removed using an excavator, and a large rock berm was
 installed to help contain future rockfalls within that area.

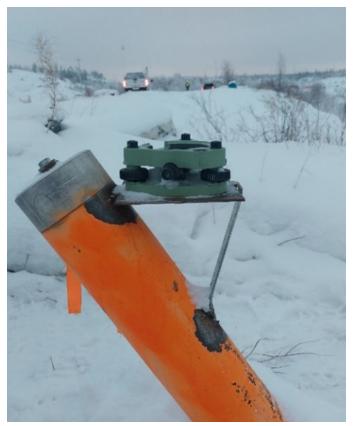
Photo 35: C1 Buttress Monitoring location

In addition, routine monitoring for stability was carried out at two pits: B1 Pit walls and C1 buttress, which has been conducted since 2013 and 2018, respectively. This monitoring is done using reflectors (called prisms) that are installed on metal rods positioned at key locations where signs of instability, such as tension cracks, have been identified. To determine if there have been any changes in location from the previous measurements, these fixed prism locations are surveyed from established stations (Photo 35) in B1 Pit (two times per year) and at the C1 buttress (monthly). By measuring the location of the prisms, it is possible to track and assess movements within millimetres of change. Frequency of sampling is increased if results showed movement of the prisms.

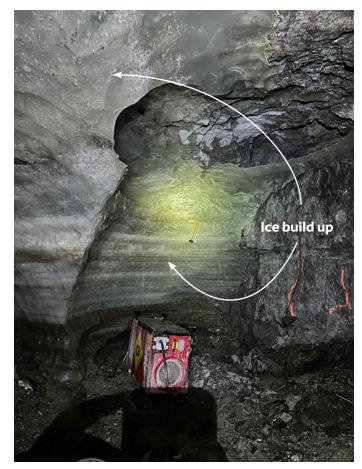
- During historical mining activities, fresh air had been pushed underground for workers and was heated at the B1 Vent Raise. As mining ceased, and areas of the mine were no longer accessed, the air into distal parts to the core area was no longer ventilated and heated. This resulted in the cooling and freezing of the rock and air in the areas away from C Shaft and B Shaft. Where water infiltrated into the underground from surface, it formed ice in the underground stopes and drifts, blocking access and filling void space. The ice buildup was observed at A1 and A2 portals and blocked access to areas where backfilling needed to occur (Photo 45). To address this, the GMRP installed local power, heating, and fans. The ice was melted through the heat and recirculation of the warm air at the "ice wall," and the area was backfilled as part of the underground stabilization program.

Photo 45: Ice Buildup Underground that Could Block Access to Areas for Remediation (heater was used to melt the ice)
